# **INDOOR AIR QUALITYASSESSMENT**

**Massachusetts Department of Transportation  
Registry of Motor Vehicles  
Watertown Branch  
550 Arsenal Street  
Watertown, Massachusetts**

Prepared by:  
Massachusetts Department of Public Health  
Bureau of Environmental Health  
Indoor Air Quality Program  
February 2019

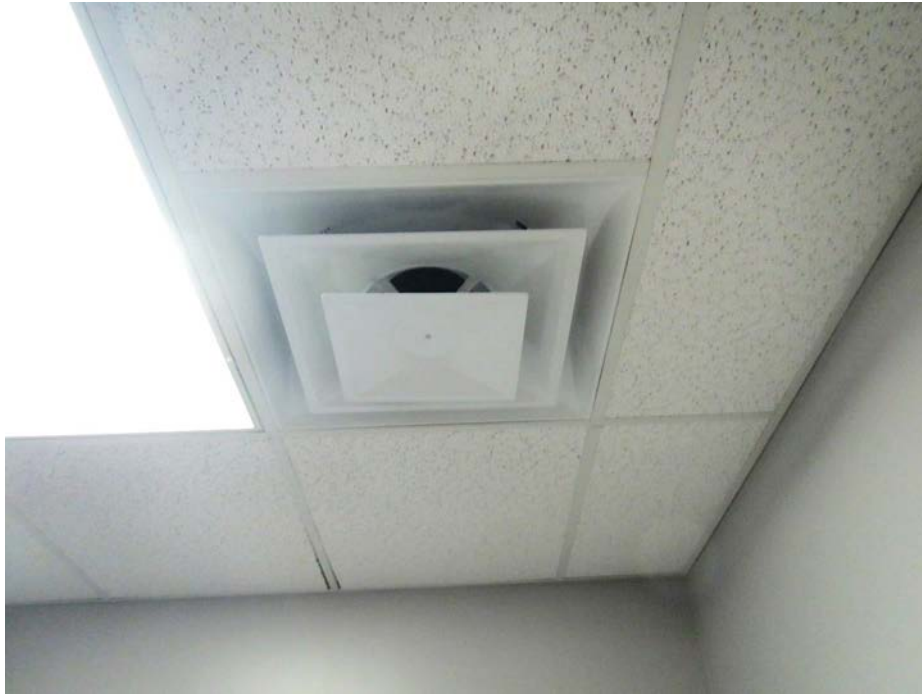
**Picture 1**

Fresh air for this space is provided by three rooftop air handling units (AHUs). Conditioned air is delivered via ceiling diffusers (Picture 1) and returned to AHUs via ceiling-mounted return grills (Picture 2). AHU filters are reportedly changed four times a year.

**Typical supply diffuser**

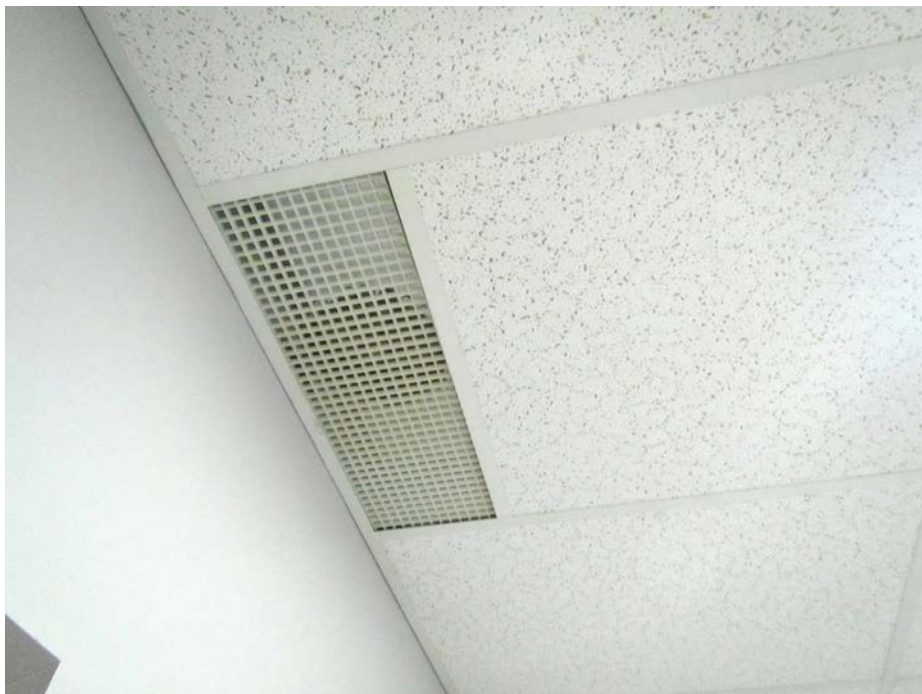
**Picture 2**

**Typical exhaust/return grill**

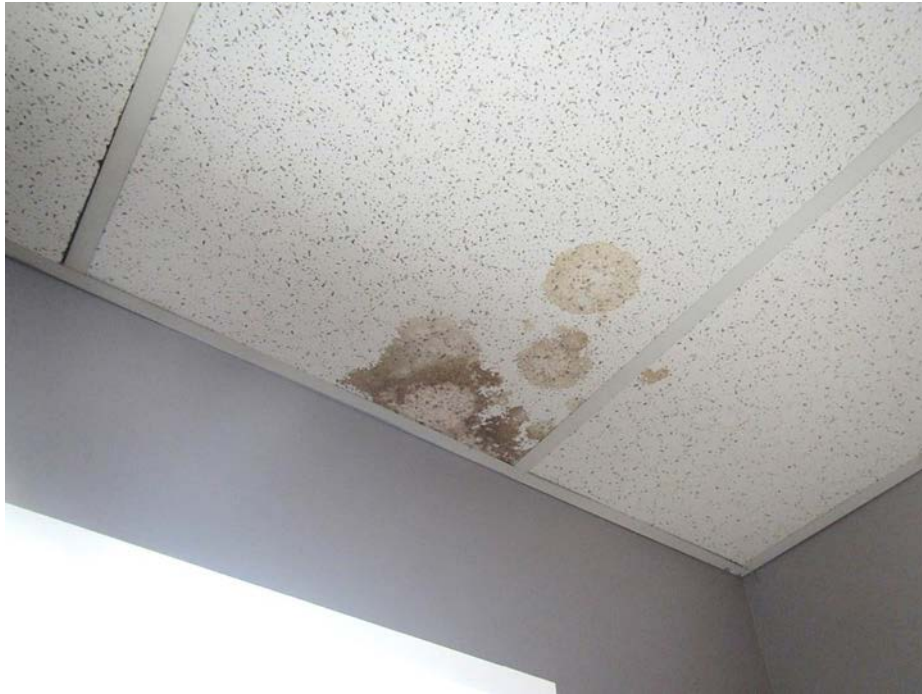
**Picture 3**

Some water-damaged ceiling tiles were noted in the space (Picture 3; Table 1). These are reportedly due to roof leaks. Water-damaged ceiling tiles can be a source of mold and should be replaced after a leak is found and repaired. During replacement, the area above the ceiling tiles should be examined and cleaned/disinfected if necessary.

**Water-damaged ceiling tiles**

5. Ensure leaks are repaired and replace water-damaged ceiling tiles. Check above tiles and clean/disinfect the area if needed.
6. Discard any water-damaged porous materials such as cardboard. Avoid storing porous materials in areas where leaks occur.

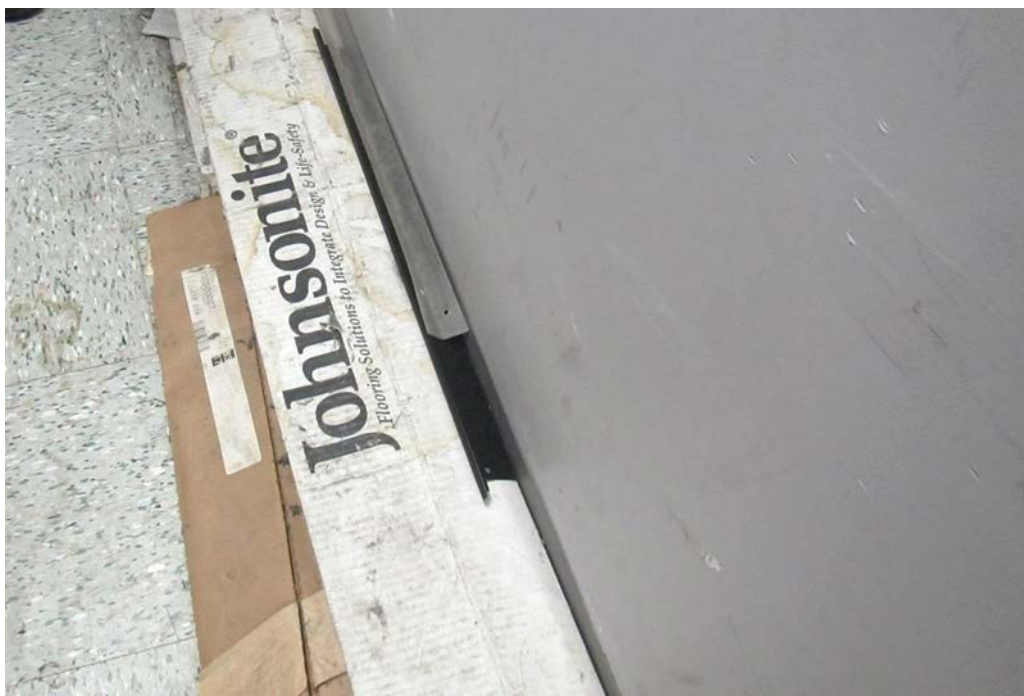
**Picture 4**

Water-damaged boxes were noted in the storage/electric room (Picture 4). It could not be determined if the water damage had occurred in this location or if the boxes had been transferred from another location. Water-damaged cardboard can be a source of mold growth and odors, so these boxes should be discarded. Porous items such as cardboard should not be stored in locations where leaks are known to occur.

**Water-damaged boxes in storeroom**

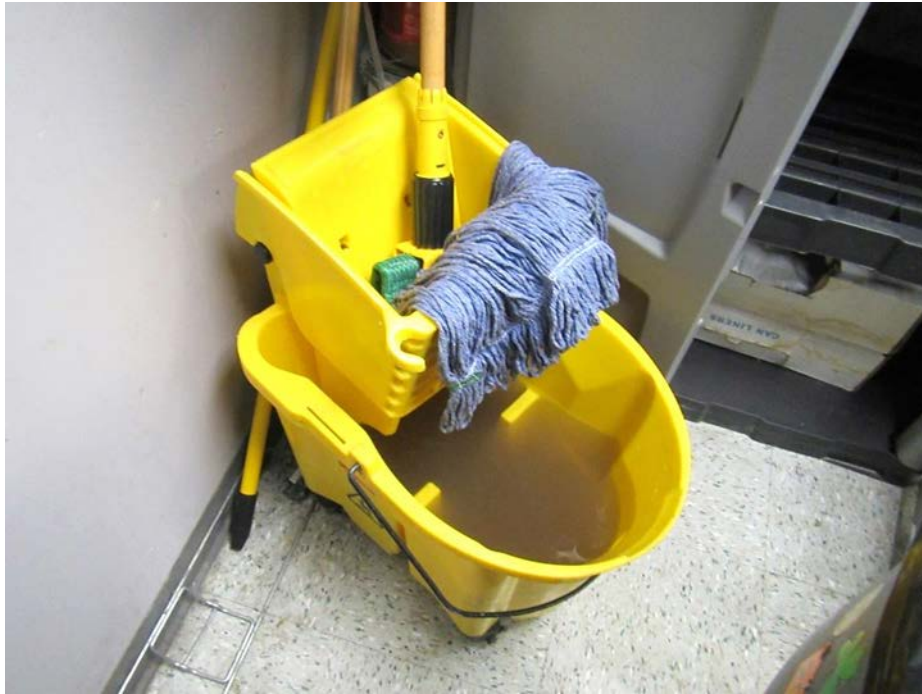
**Picture 5**

A mop bucket with dirty water was noted in the rear hallway that is also used as a janitorial supply closet (Picture 5). Stagnant water can be a source of odors and damp mops can become colonized with mold. Buckets should be emptied and mops should be dried after use. Note that there is no apparent janitorial sink in this space, which may mean cleaning personnel need to travel a long distance through occupied areas to drain and clean equipment.

**Mop bucket filled with dirty water**

7. Ensure mop buckets are drained and cleaned after use.
8. Repair damaged exterior doors or replace if needed.
9. Ensure doors to the outside are tightly-fitted with weather-stripping to exclude moisture and pests.

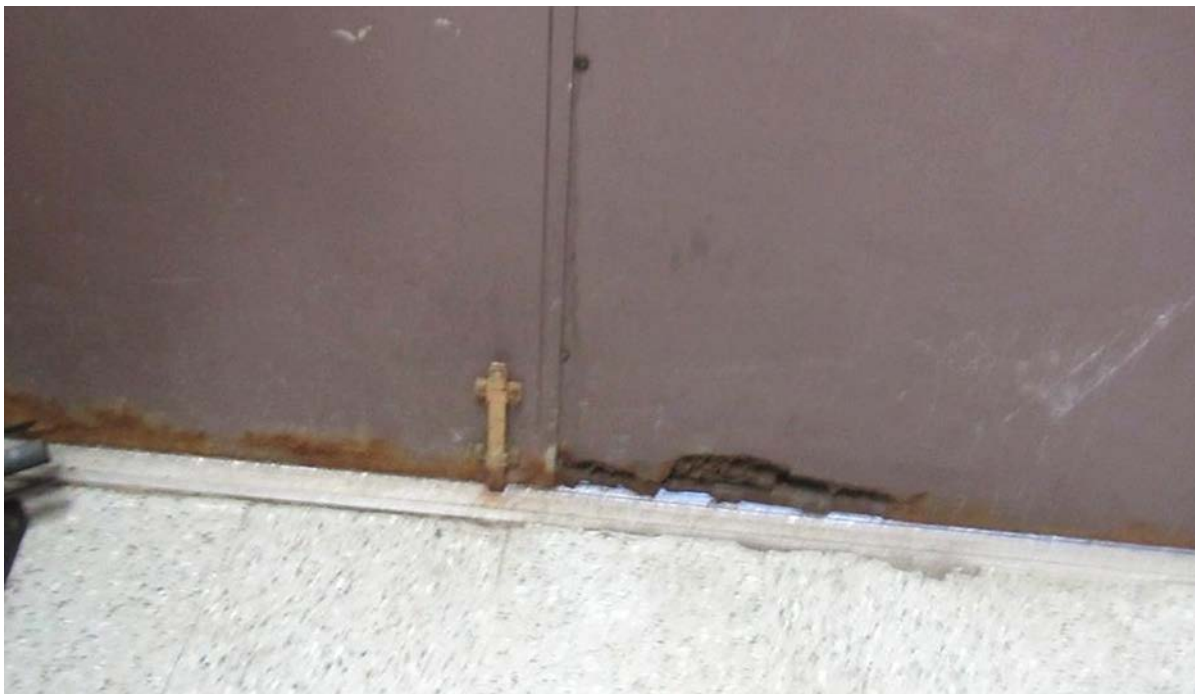
**Picture 6**

This hallway also had a door to the outside, which had a hole rusted in it (Picture 6). Exterior doors should be rendered weather-tight to prevent the entry of moisture, unconditioned air and pests.

**Hole in the bottom of rear door to outside**

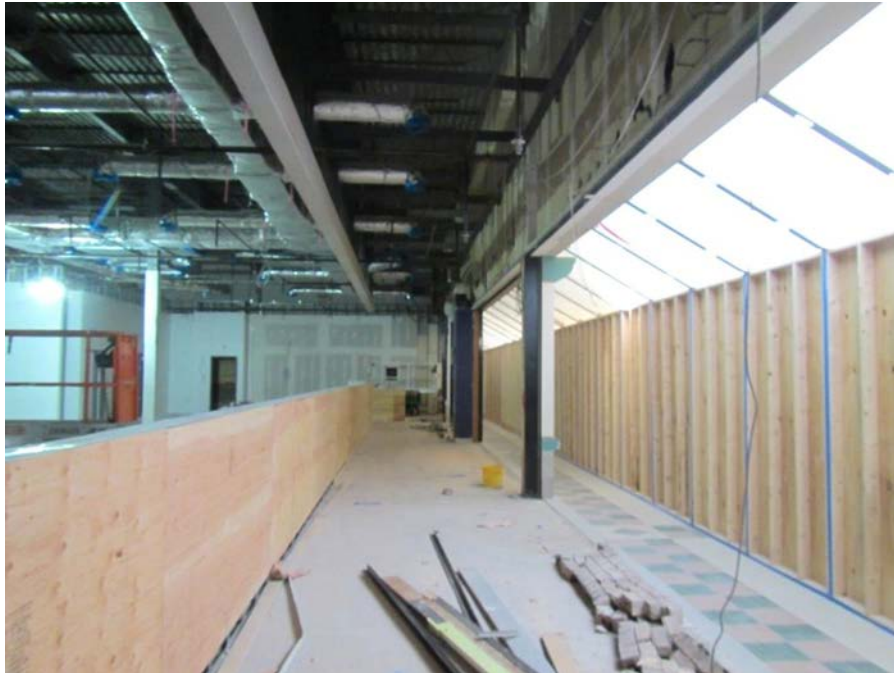
**Picture 7**

As previously mentioned, concerns regarding the impact of construction on occupants in the RMV prompted this assessment. Note that at the time of the visit, there was no significant construction activity occurring. Previous activities included: demolition of existing walls, removal of fixtures, HVAC installation, installation of wallboard, plumbing and electrical work, and remediation of asbestos-containing floor tiles. The area under construction had been sealed off with a barrier made of plywood and plastic sheeting (Picture 7). At the time of the visit, this

**Barrier wall between construction area and mall hallway from inside construction zone  
(barrier on right side of picture)**

10. Keep the barriers between the construction area and other areas intact during construction. Follow the guidance in “Methods Used to Reduce/Prevent Exposure to Construction/Renovation Generated Pollutants in Occupied Buildings” ([Appendix A](#)).

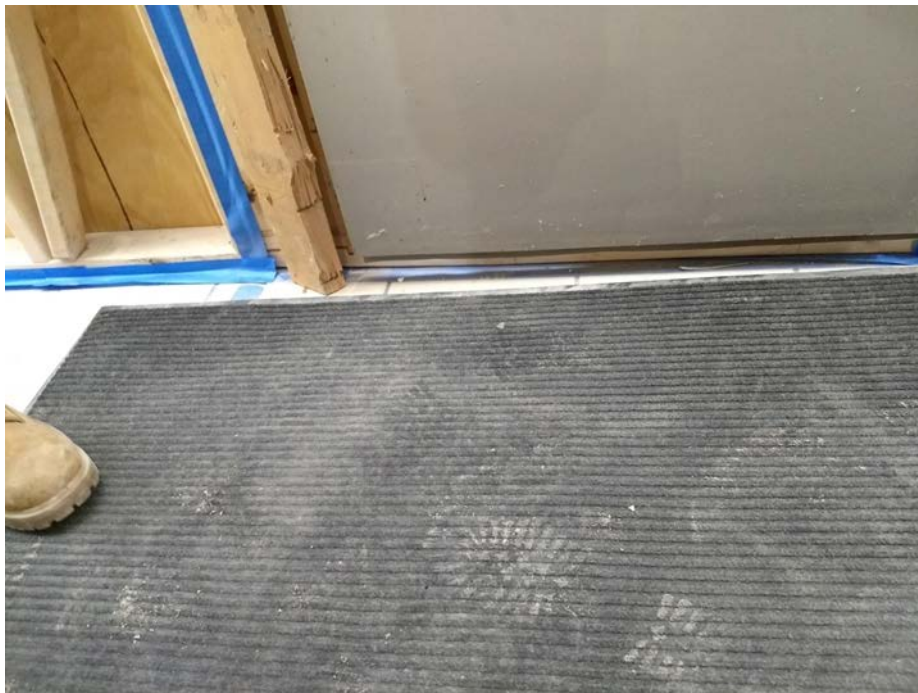
**Picture 8**

barrier was intact and taped to provide a tight seal. A single door from the construction area into the mall hallway is present and a small amount of light was visible around it (Picture 8). The construction manager reported that most construction materials are brought into/out of the area using exterior doors so materials are not moved through the mall.

**Construction door with light penetrating beneath**

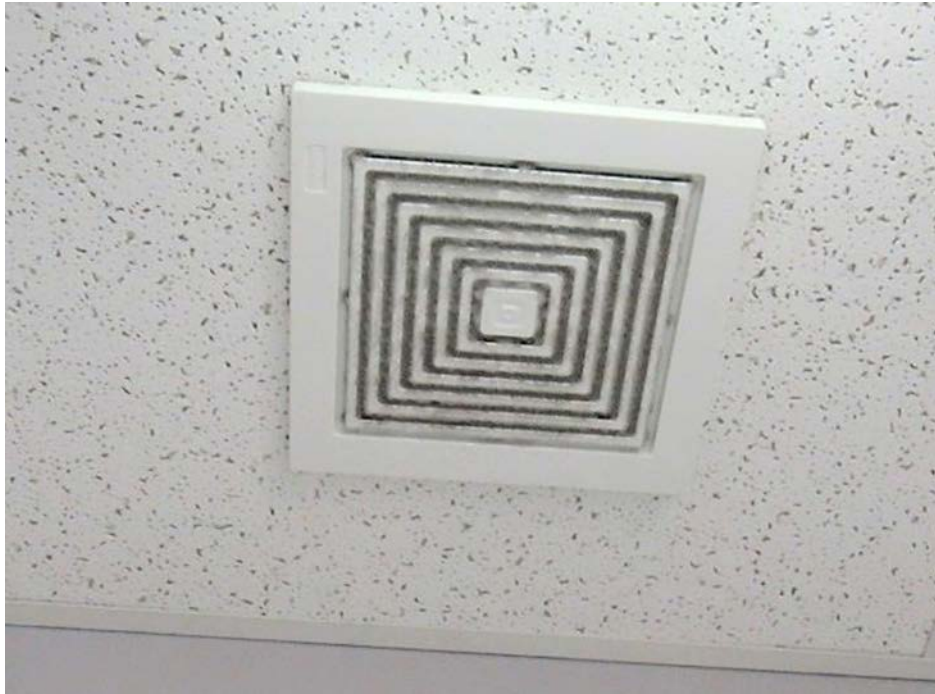
**Picture 9**

There was a build-up of dust on some exhaust vents (Picture 9). This dust can be reaerosolized and cause irritation. Occupants also reported concerns about dust on surfaces. Flat surfaces should be cleaned periodically with a damp cloth to remove dust.

**Dusty exhaust vent in a restroom**

13. Clean supply and exhaust vents, fans, and flat surfaces of dust periodically.
14. Vacuum carpeting daily using a vacuum equipped with a HEPA filter.

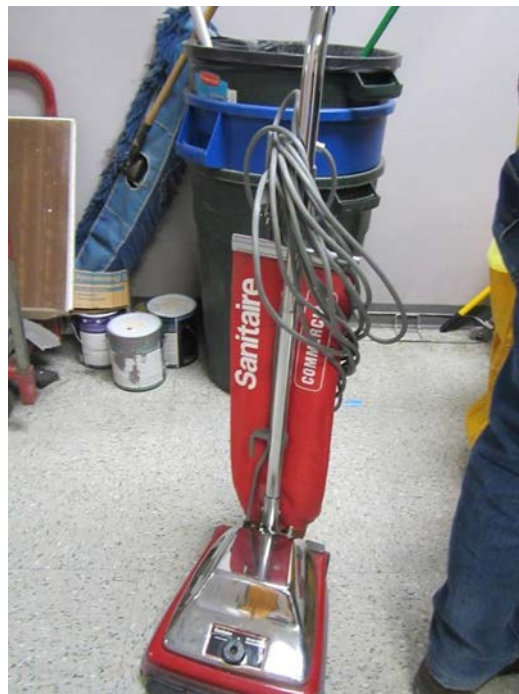
**Picture 10**

Several areas were carpeted. Carpets should be cleaned annually (or semi-annually in soiled/high traffic areas) in accordance with Institute of Inspection, Cleaning and Restoration Certification (IICRC) recommendations, (IICRC, 2012). Regular cleaning with a high efficiency particulate air (HEPA) filtered vacuum in combination with an annual cleaning will help to reduce accumulation and potential aerosolization of materials from carpeting. Note that the vacuum cleaner present on site (Picture 10) does not have a HEPA filter.

**Non-HEPA vacuum cleaner used in the space**
